Docket No. 217 – Development and Management Plan Inspection

Northeast Utilities Service Company Certificate of Environmental Compatibility and Public Need for the construction of a 345-kV electric transmission line and reconstruction of an existing 115-kV electric transmission line between Connecticut Light and Power Company's Plumtree Substation in Bethel, through the towns of Redding, Weston, and Wilton, and to the Norwalk Substation in Norwalk, Connecticut.

Norwalk Substation

Plumtree Substation

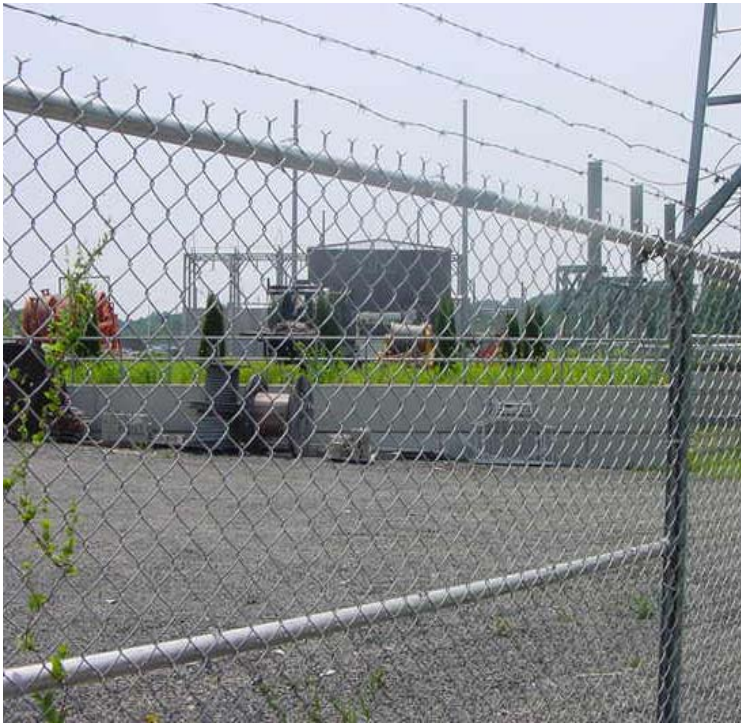
(Norwalk Substation): Photo on the left shows some equipment on site preparing to pull ropes and wires from the structures. Continue to monitor and maintain while on site. Photo on the right shows where stones were placed around the turning structure base to repair the erosion. 7/26/06

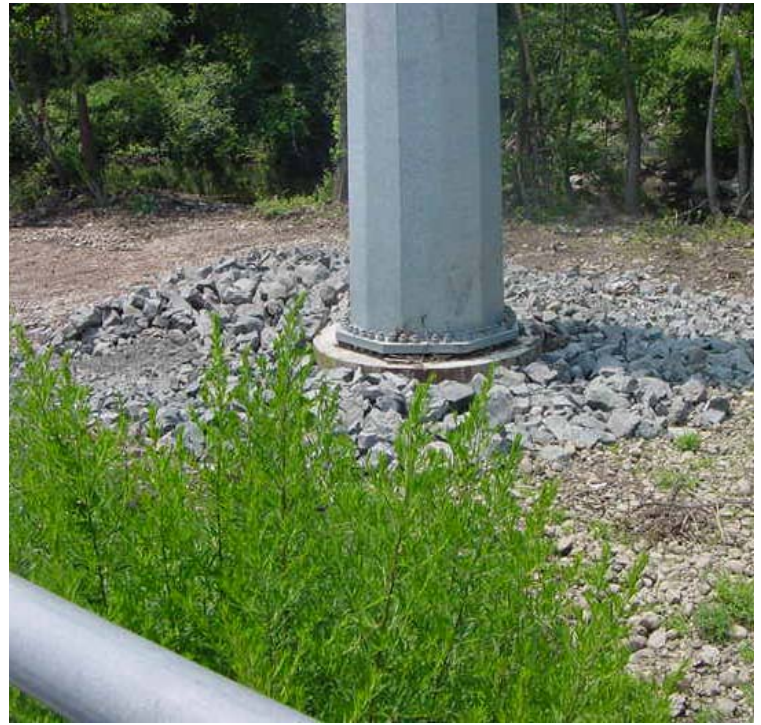
Areas of Inspection	Observation	Recommended Action	Corrected Action
Access Roads and Adjacent Roadways	- The catch basin near the Route 7 ramp receives a lot of off-site stormwater-sedimentation of roadway sand is occurring here. 12/22-7/26/06.	-The area should no longer be affected by any onsite sediment. The silt fence could be removed. 12/1-7/26/06.	-N/A.
Foundation construction	-Remaining work involves electrical testing. 7/26/06. - MJ Electric was on site preparing to pull ropes. 7/26/06 -New stone was noted around the base of the 345kV turning structure to repair the erosion. 7/26/06	- None at this time. Little to no soil disturbing work is occurring. 5/17-7/26/06. - None at this time. 7/26/06 -Continue to monitor. 7/26/06	-N/A -N/A - Stone was added
Erosion and Sediment Controls	- Erosion on the slope of the river appears to be forming again. 6/28-7/26/06. - Stone was placed around the inlet on site in an effort to filter run-off. 6/20-7/26/05	- Continue to monitor and attempt to make the area more natural/ vegetated if feasible. 5/25-7/26/06. - Continue to monitor to determine if this control works to reduce turbidity to the river. 7/26/06	-Stone was placed at the base of the turning structure -N/A

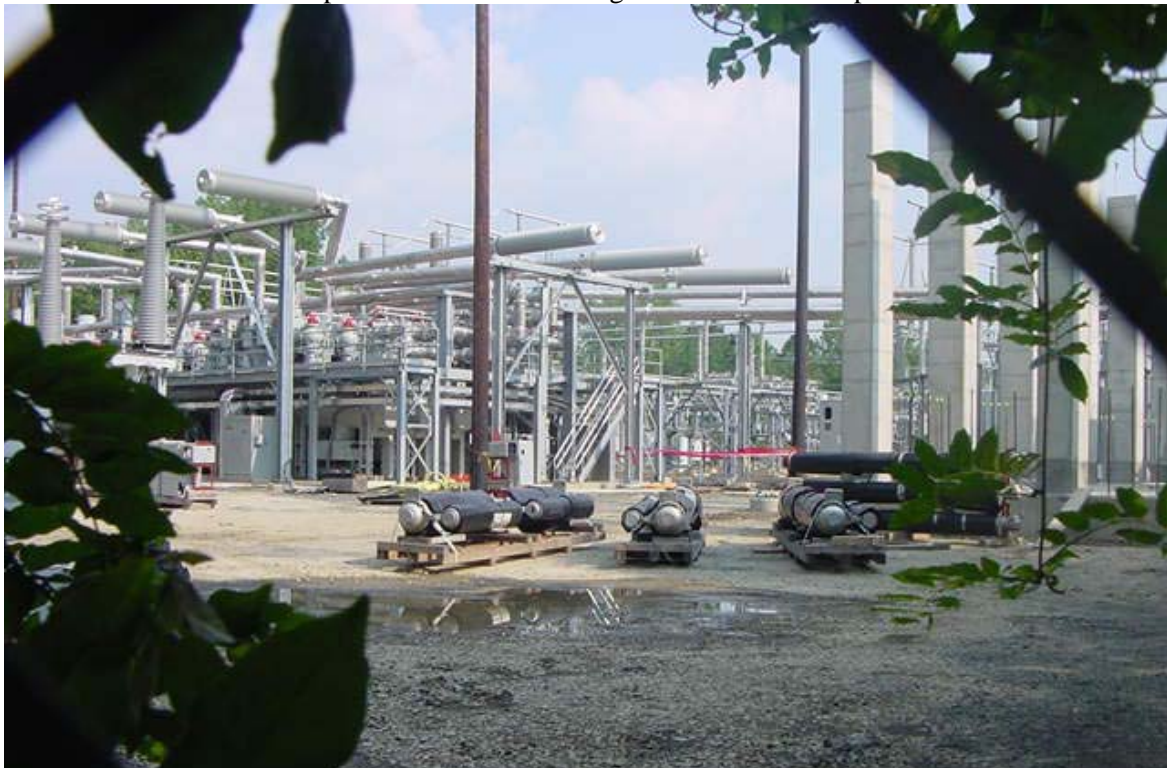
(Plumtree Substation): Photo shows a view of the ongoing work in progress in the yard. 7/26/06
